## Barry Ave Parking Ramp

*Project Case Study*

**SCOPE OF WORK:** Wall Replacement

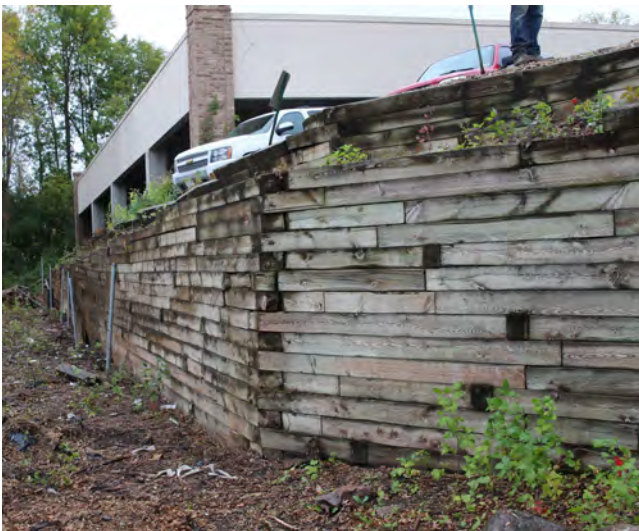
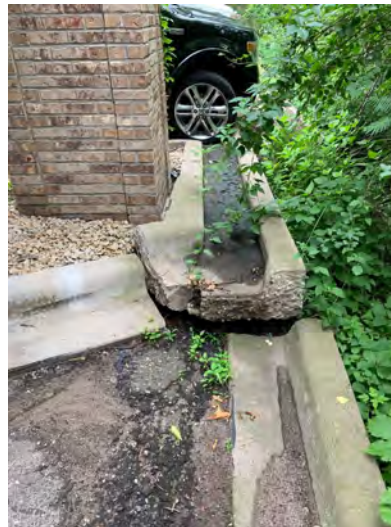
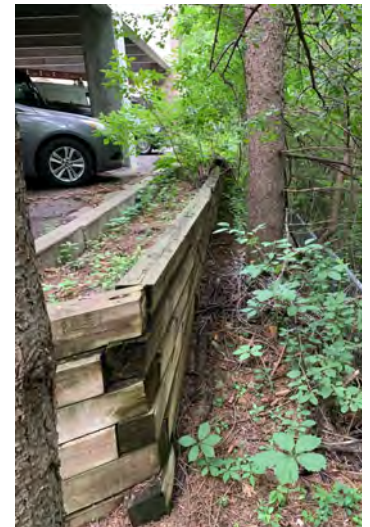
When the original parking lot was constructed, over 8 feet of swamp land was filled in to create the space. So, before a new design for the lot could be developed, the soil needed to be tested to determine exactly where the peat was located and how much more settlement would be expected to the area over time. WSB

Engineering was called in to do some testing of the soil under the lot. They used a Shelby tube to collect undisturbed soil samples to determine soil density and water content in order to evaluate the current level of strength and compressibility. They also did some consolidation testing to get an idea of how much more settlement could be expected with the existing soil. This data helped the design team to better understand what was going on under the lot and allowed them to come up with solutions for the settlement issue.

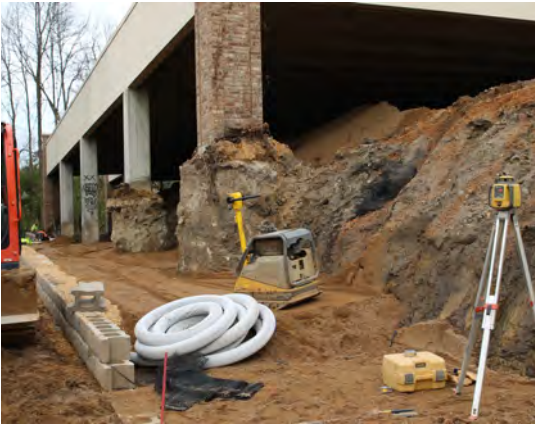
The initial testing determined that the lot was basically floating on top of the bog and they were going to need to be careful about adding any additional surcharge to the structure if they were going to keep the lot from settling further. The original retaining walls holding the parking lot in place were a set of terraced timber walls. These were to be replaced with a single concrete block retaining wall using the Veteran Pro block with the hewn face. This meant that the aggregates used to fill in behind the new wall were going to need to be lighter so as not to add additional pressure. This is where Hardscape Construction and GeoWall Designs had to think outside the box to find the right solution.

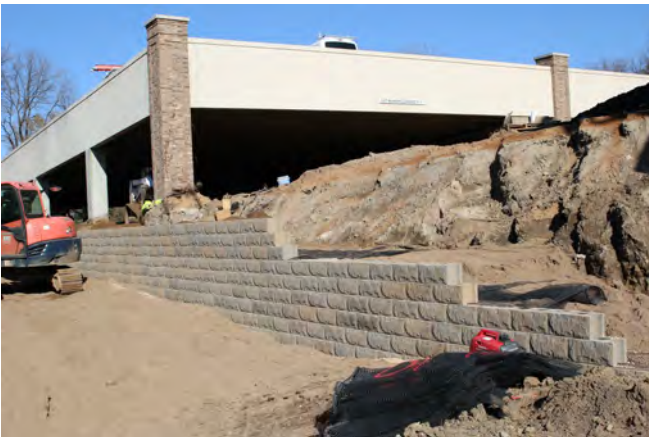
Using lighter fill options for retaining walls is not a new concept and there are a variety of options available on the market. GeoWall Designs suggested foam to Hardscape Construction as an initial solution to the project. They determined that the cost and the learning curve for the crew would be over the budget and went back to the drawing board for other ideas. They next came up with a lightweight aggregate that was approximately 40 lbs. per cubic foot but ruled this out as well do to cost. Which led them to their third option, recycled tire chips. Typically used in road applications in swamp areas with a great level of success but had never been used in a wall application such as this.

In order to consider these recycled tire chips as a viable option, Kyle Huerd with GeoWall Designs needed more information and contacted Liberty Tire Recycling, based out of Pittsburg, PA. Tim Landers, the Midwest sales director based out of their Savage, MN manufacturing location, provided Huerd with MN DOT testing, and a variety of other information of what this type of aggregate was capable of. Through their communication they determined that the

recycled tire aggregate in combination with granular sand could meet the need for a lighter aggregate and still provide the right amount of friction needed while staying within the cost constraints of the project.

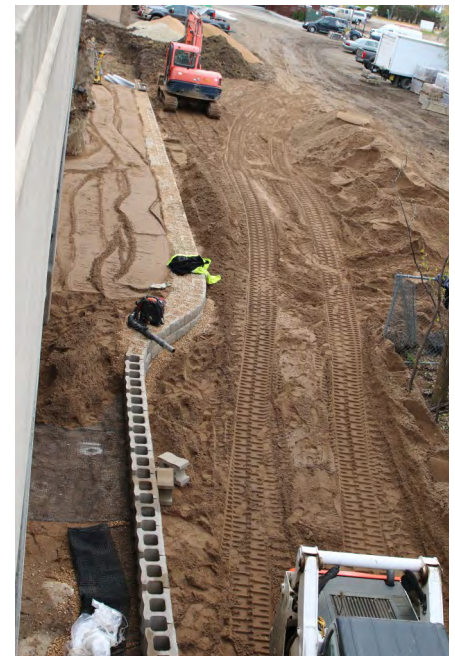
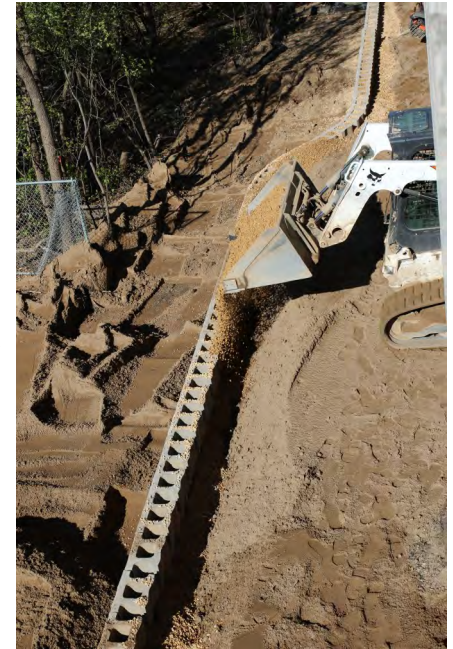
Since tire chips had never been used before on a retaining wall and there is no compaction testing, the design and construction teams, knew they would need to do extensive field testing to make sure they had the right mix. The plan was to use a mix of 75% locally manufactured recycled tire chips and 25% granular sand behind the retaining walls. This mixture would be hand mixed on site as they backfilled the wall.

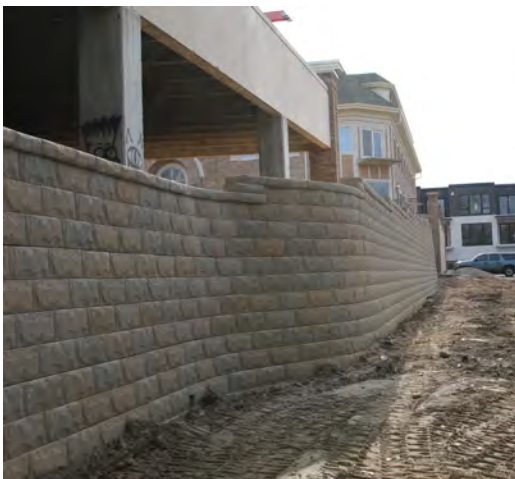
Fabric was used at the base level with double wrapped geogrid and rock to reinforce the base and essentially create a floating platform above the base. All of this was extremely complicated in application because of the proximity to the ground water and the swamp itself. When it came time to begin the backfilling behind the wall, they faced their next set of challenges.

On the first day of backfilling, they found that the 75/25 mix just did not have the right friction ratio and based on the years of experience between the design and construction teams they determined a 50/50 ratio would be a more conservative mix. They used the best practices for retaining wall construction guidelines to install geogrid every two courses throughout the retaining wall and brought in additional granular sand to get out of the ground water at the base. To finish the structure, they added a foot of Class 5 material before installing the asphalt to top off the parking lot.
